**CONNECTICUT RIVER BASIN
HAVERHILL, NEW HAMPSHIRE**

OLSEN DAM

NH 00190

**PHASE I INSPECTION REPORT
NATIONAL DAM INSPECTION PROGRAM**

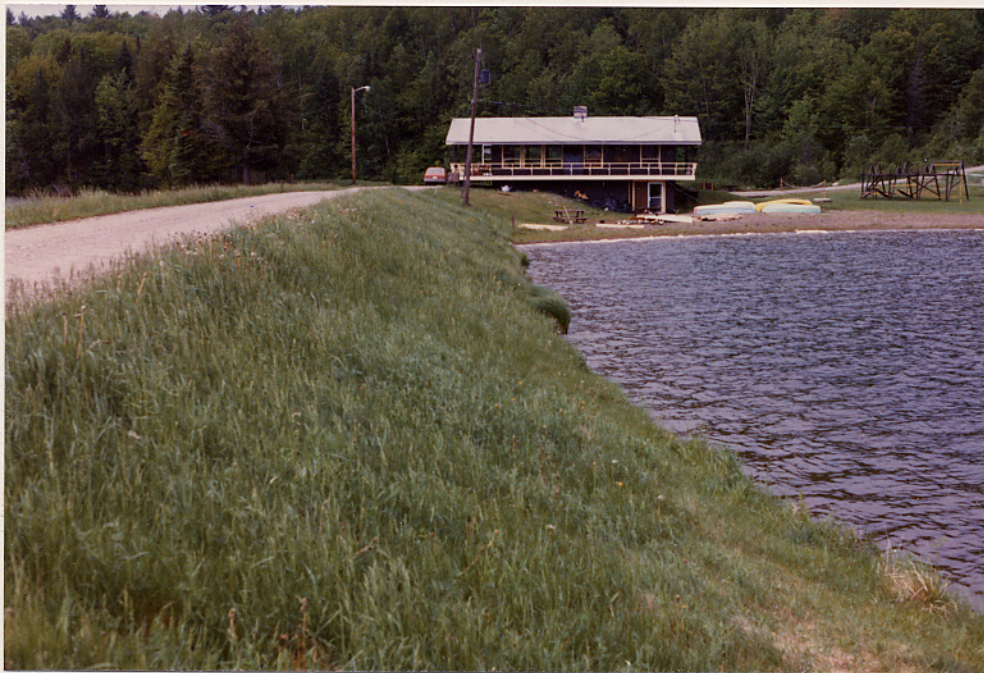
1. Downstream slope from right abutment

If and when the downstream reservoir is lowered, it is recommended that the services of a qualified registered professional engineer be retained to evaluate the condition of the downstream slope and the outlet conduit which are presently submerged.

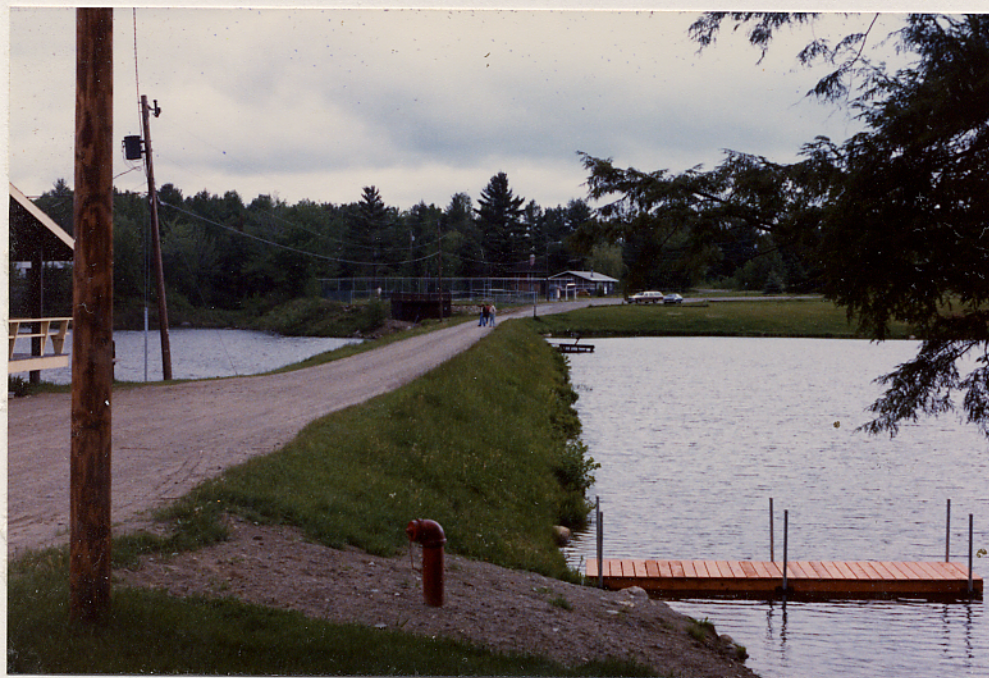
The embankment appears to be in good condition at the present time. The upstream slope at the waterline shows some signs of erosion and undercutting due to wave action. A few small shrubs are growing on the upstream slope at the water line. At approximately midlength along the downstream slope are a few small (2 inch) animal burrows approximately four feet below the crest of the dam. There are utility poles embedded in the embankment and a compacted gravel roadway running along the crest to a club house at the left end of the embankment.

2. Upstream slope from left end of embankment
Note minor undercutting of slope at water line

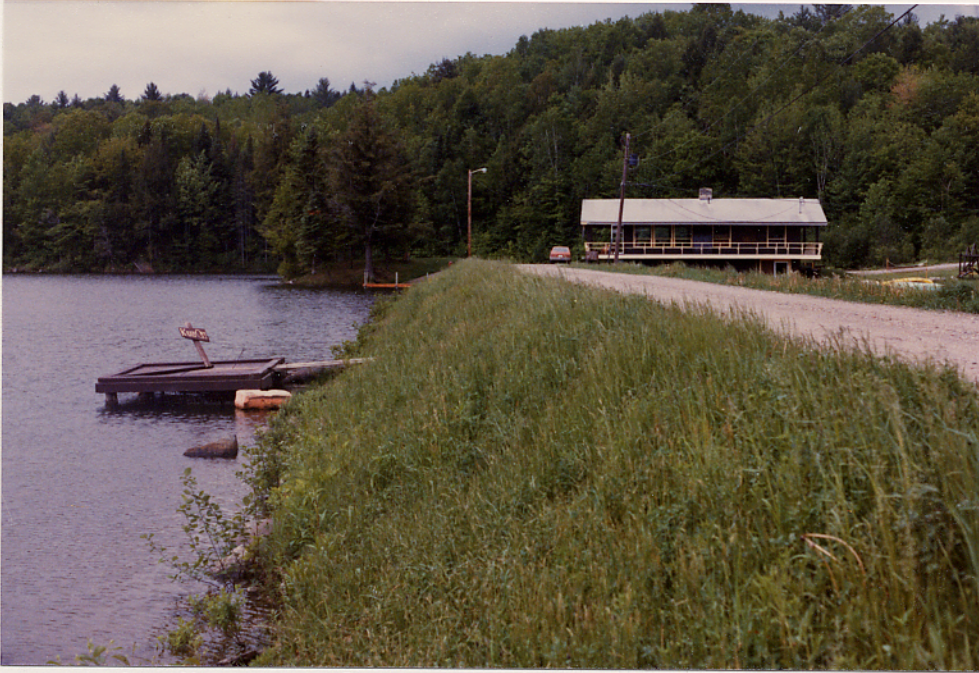
3. Upstream slope and principal spillway

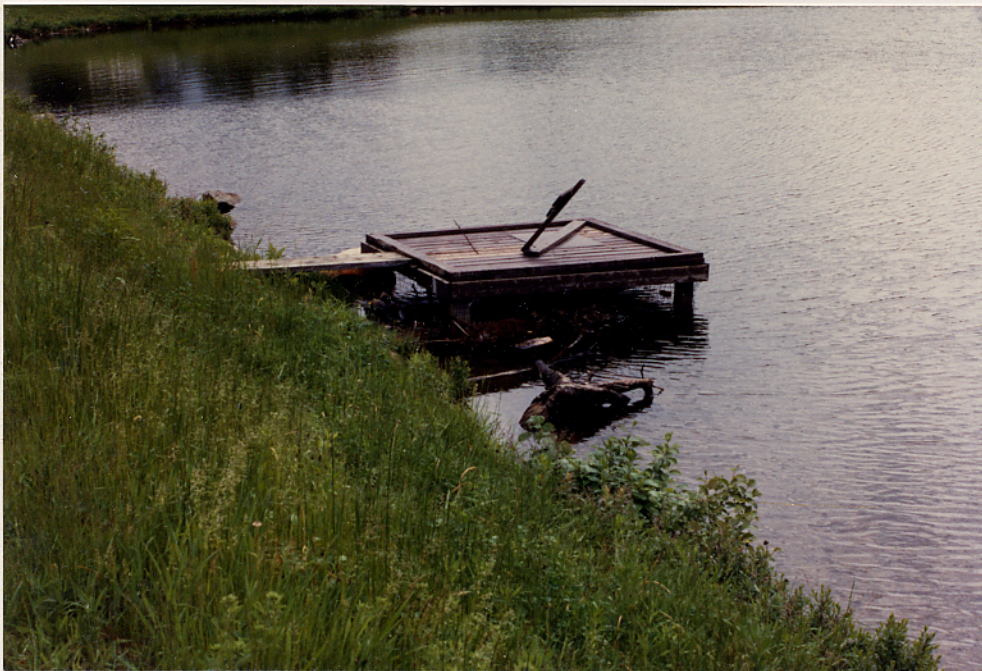
The drop inlet riser is enclosed with a wooden deck and protected by two wire screen trash racks around the inlet and the deck. The deck and trash rack appear to be in good condition. There is some debris caught in the trash racks.

4. Platform over drop inlet type
Principal spillway

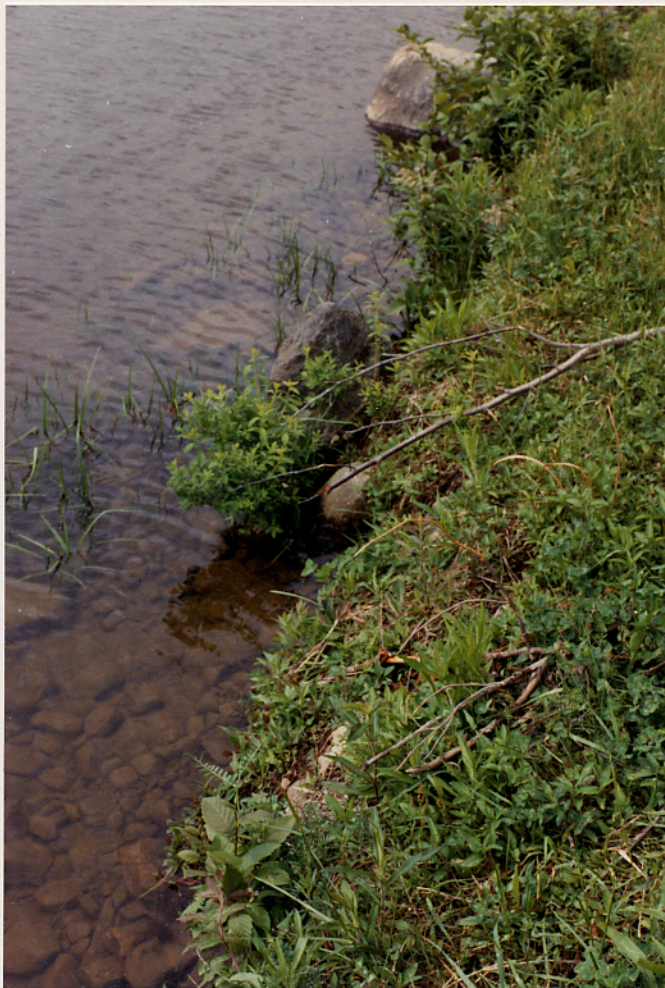
5. Upstream waterline showing minimal erosion protection

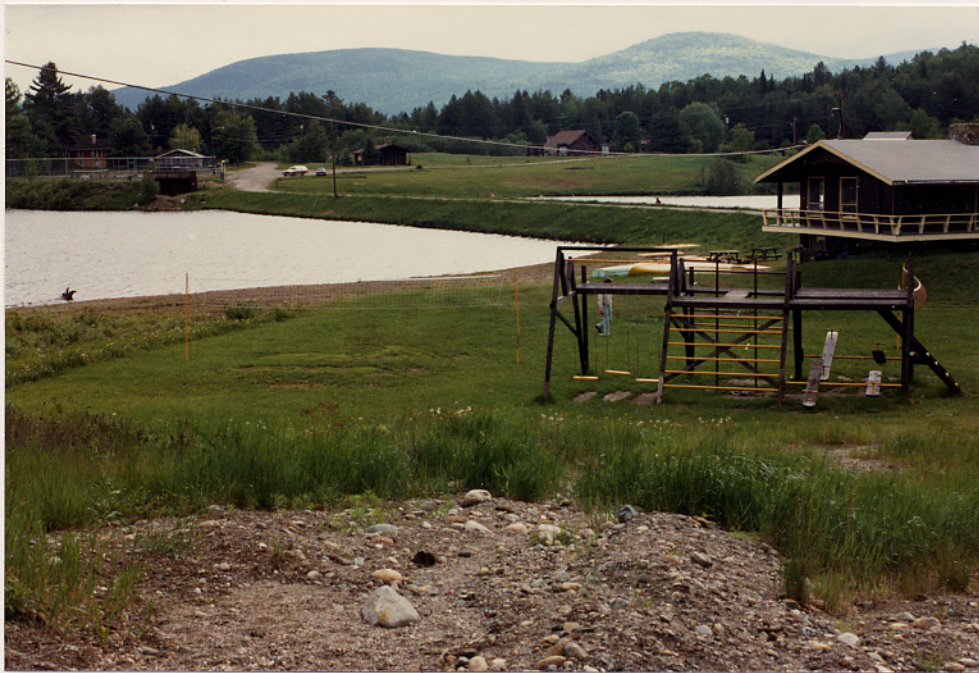
The emergency spillway is located at the left abutment. There is a play area and beach including recreation equipment located on the emergency spillway which is a grasslined channel. The channel appears to be in good condition with the exception of the equipment which would restrict flow.

6. Downstream end of emergency spillway from left abutment

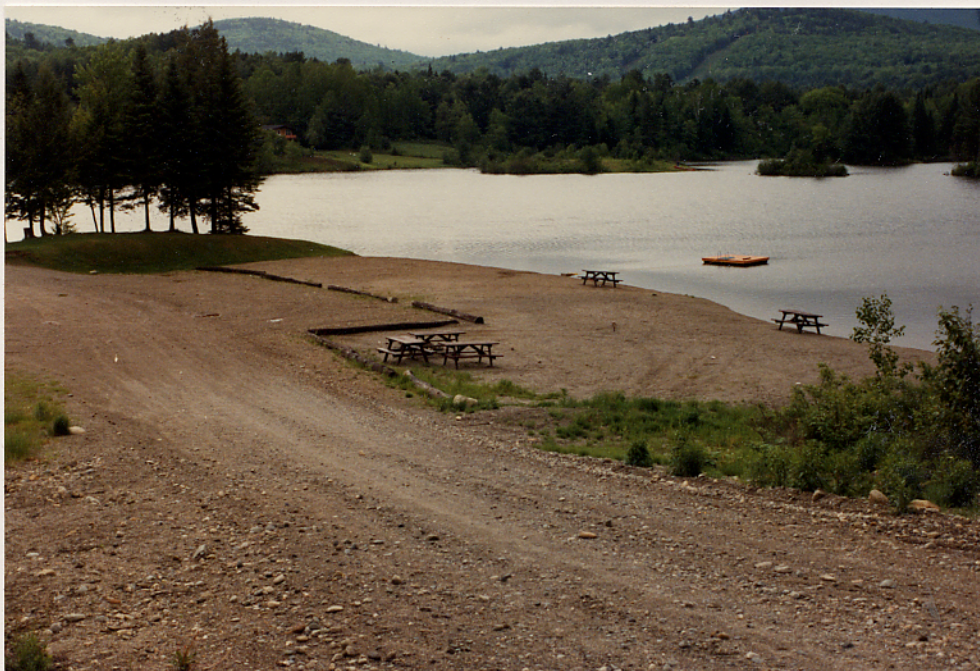
7. Upstream end of emergency spillway from left abutment
